Mercury Emissions from a Synthetic Gym Floor

Risk-based Assessment, Control and Verification during Removal

Zehra Schneider-Graham, University of Massachusetts Boston
William Wade, Environmental Health and Engineering, Inc.
Joseph Allen, Environmental Health and Engineering, Inc.

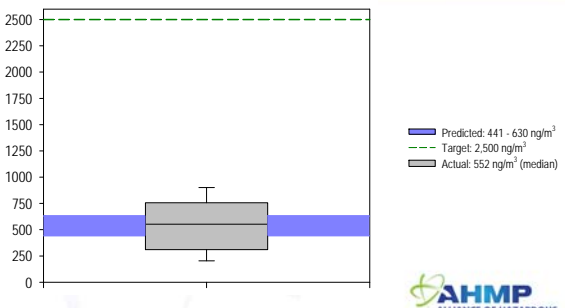
Emissions from Cleaned Concrete

- Predicted: 441 - 630 ng/m³
- Target: 2,500 ng/m³
- Actual: 552 ng/m³ (median)
