Over-Pressurization of Compressed Gas Cylinders

HMP
ALLIANCE OF HAZARDOUS MATERIAL PROFESSIONALS
ORLANDO 2013

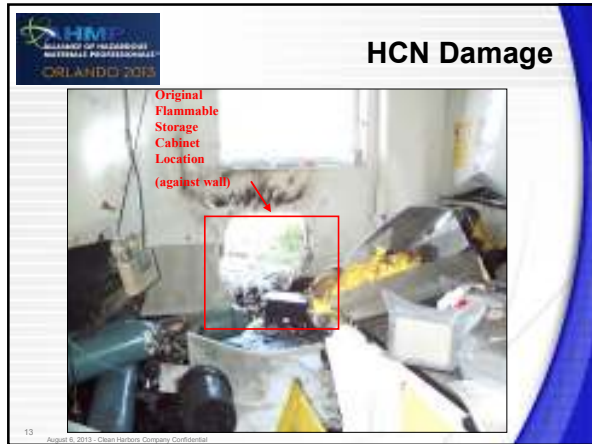
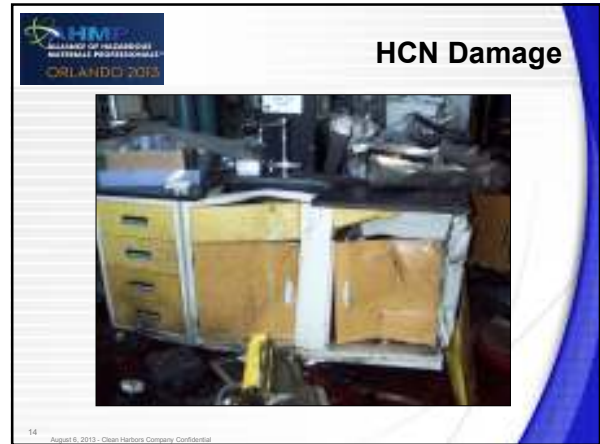
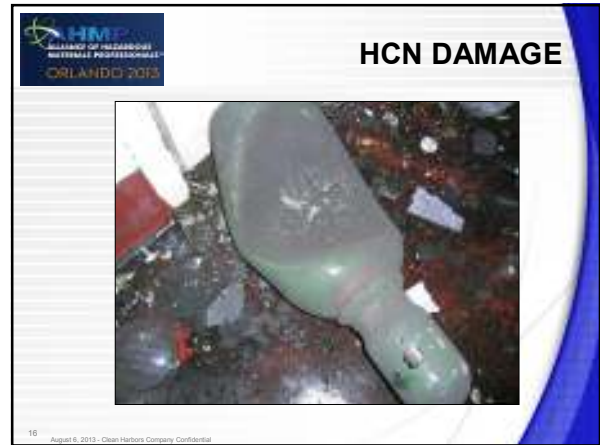
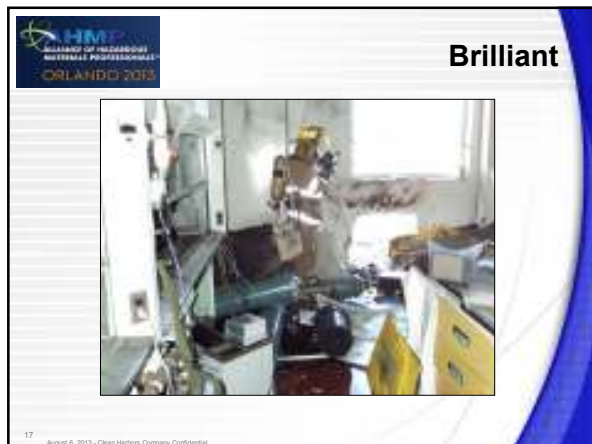
HCN Damage

- ### Causes
- Age of HCN was over 1 year. HCN has a 30 day shelf life that should not be exceeded.
 - Depletion of sulfuric acid inhibitor within the cyanide.
 - Accelerated inhibitor depletion may have been caused by defects within the steel of the cylinder.
 - Increase in the rate of polymerization until the critical temperature of HCN was reached.
- 18 August 6, 2013 - Clean Harbors Company Confidential

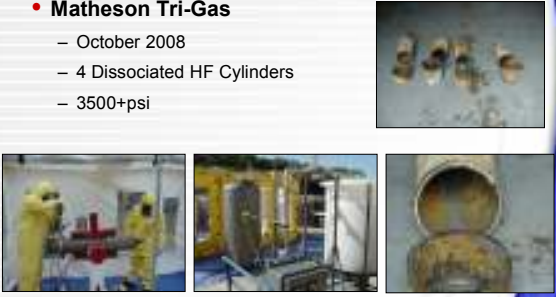
Hydrogen Fluoride Remediation

- **Matheson Tri-Gas**
 - October 2008
 - 4 Dissociated HF Cylinders
 - 3500+psi
