City of Austin - Goodwin Site Brownfield Revitalization Project Guadalupe – Saldana Net Zero Subdivision

Alliance of Hazardous Materials
Professionals National Conference
September 17, 2013

Authors:
Shivani Kesar, P.E., PMP – CB&I
Steve R. Nelson, P.G., PMP – City of Austin Public Works Department

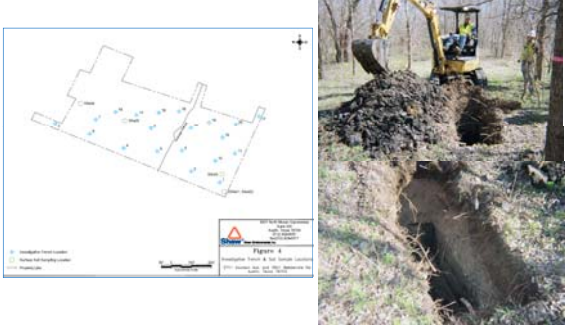
The slide contains a site map on the left showing property boundaries and sampling locations marked with blue dots. On the right is a photograph of a deep excavation trench with a yellow excavator and a worker in safety gear. A legend and title block are located at the bottom left of the map area.

- Waste debris was scattered across much of the site. Investigative subsurface excavations completed at the site indicated that concrete and other construction related debris was limited to a depth of 1 to 1.5 ft bgs or less.
- Analytical results for trench samples collected for waste characterization analyses indicate that detected chemical concentration were below both the EPA hazardous and Texas Class 1 nonhazardous regulatory limits.
- Total lead was detected in the two (2) soil samples collected from the automobile battery dump area at concentrations above the TRRP Tier 1 Residential $^{GW}Soil_{Ing}$ PCL one was above the $^{Tot}Soil_{Comb}$ PCL.

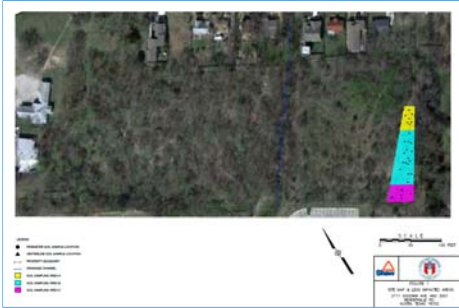
Delineation of Lead Impacted Soil July 2011

To delineate the extent of lead impacted soil horizontally and vertically, soil samples were collected and analyzed for lead from three (3) impacted areas (Area A, B, and C). SPLP test was also performed on the deepest sample to determine the mobility of lead and its leaching properties to groundwater. The analytical results were compared to TRRP Tier 2 residential ^{GW}Soil_{ing} PCL of 549.07 mg/kg was calculated for lead utilizing site-specific pH.

Each perimeter sample location consisted of two (2) soil samples that were sampled at the ground surface and six (6) inches below ground surface. Each centerline sample location consisted of four (4) soil samples that were sampled at depths of one (1), two (2), three (3), and four (4) feet below ground surface.

The laboratory analytical results indicate that lead impacted soils were delineated to a depth of:

- 4 feet in Area A,
- 5 feet in Area B,
- 6 inches in Area C.

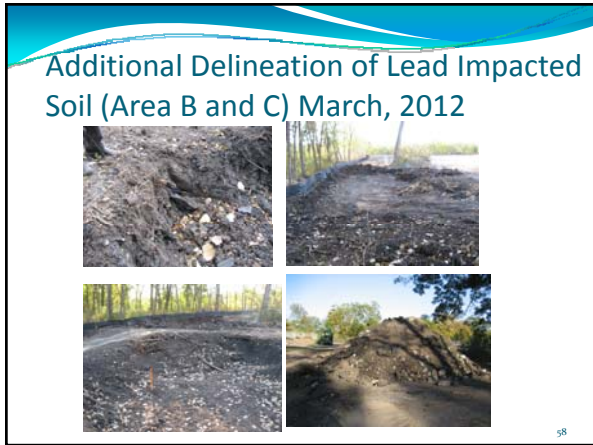
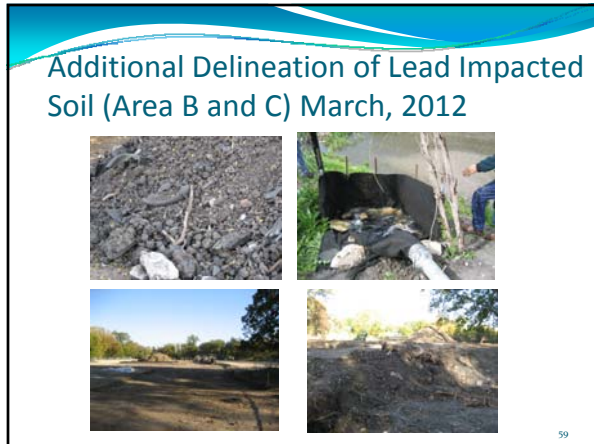
Additional Delineation of Lead Impacted Soil (Area B and C) March, 2012

- Soil samples from Areas B and C lead impacted areas were analyzed utilizing X-Ray Fluorescence (XRF) technology
- Horizontal and vertical delineation of lead impacted soil was determined by collecting wall and ground surface samples 6 inches below ground
- For quality assurance and quality control purposes a set of soil samples analyzed using the XRF technology were split and submitted to Laboratory to check accuracy of the results

Additional Delineation of Lead Impacted Soil (Area B and C) March 2012 and Excavation April 2012

- The XRF field data and laboratory analytical results indicate that lead impacted soils were delineated to an additional depth of six (6) inches within Areas B and to an additional depth of 1.5 feet in Area C.
- Analytical results also indicate that lead impacted soils were horizontally and vertically delineated below the site specific calculated TRRP $^{TotalSoil}_{Comb}$ of 500mg/kg in Areas B and C.
- Area A was horizontally and vertically delineated during the June, 2011, ESA activities.
- A total of 660.11 tons of lead impacted soil was removed and transported for disposal as indicated in the report entitled Webberville Road & Goodwin Avenue Lead Soil Remediation Report April 2012, SWS Environmental Services.
